Unacceptable reworked parts examples.

GAD-VA-011 Rework Visual
Aid 5.7.20 Rev 0

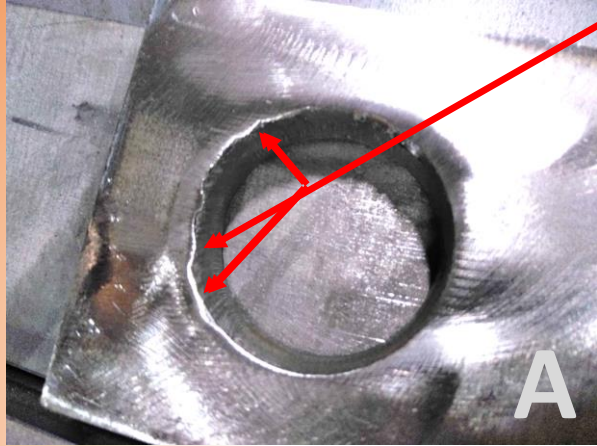
Picture **A** has been reworked for laser slag but an issue still exists within the hole where there is still material protruding into the ID, causing it to be out of hole diameter tolerance.

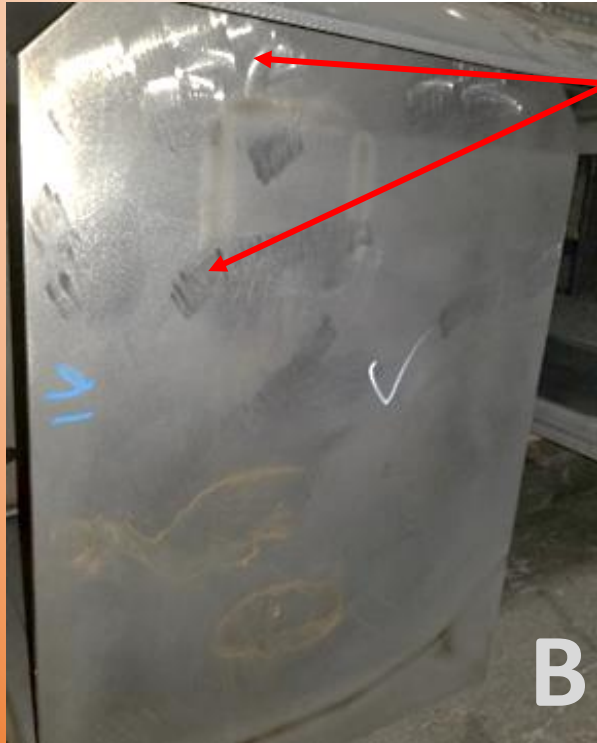
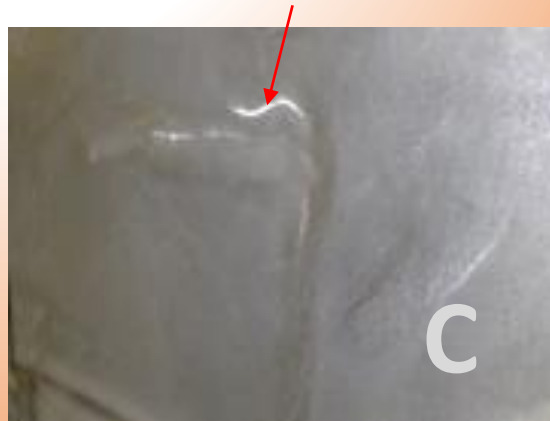
Pictures **B** and **C** have been reworked for surface scratches with a powered grinder and in this case caused deep grinder marks in the surface of the part that are visible after paint at the customer.

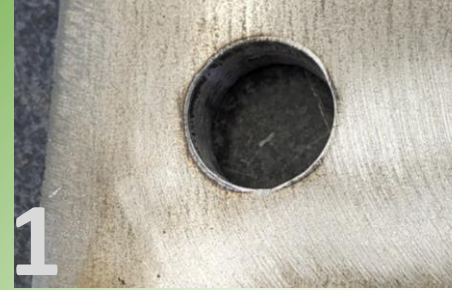
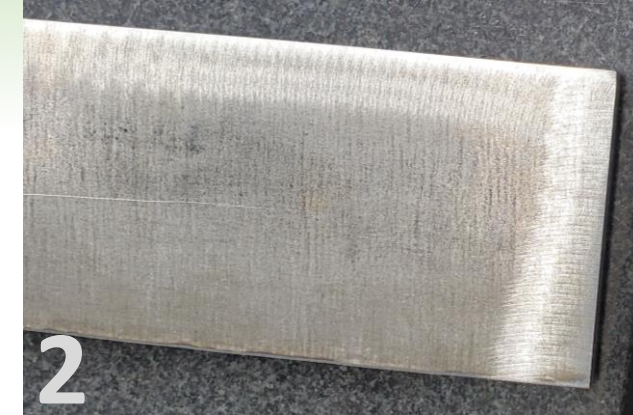
Picture **1** has been properly reworked with a powered grinder and has clean uniform edge around the diameter of the hole. Picture **2** also has clean reworked edges where laser slag was present.

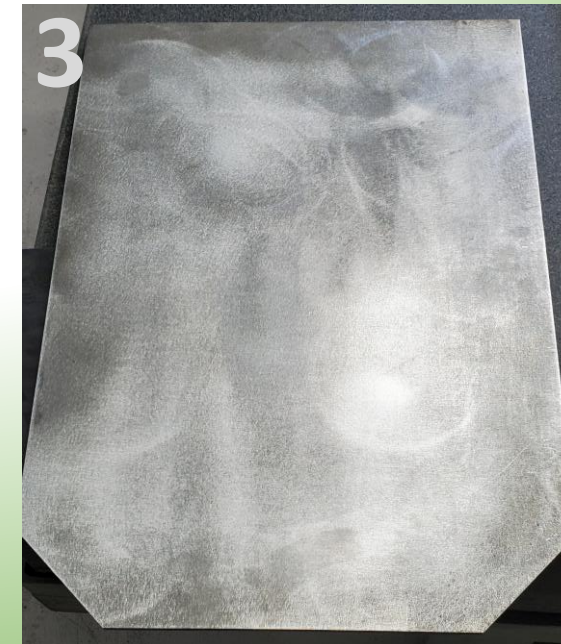
Picture **3** had surface scratches and was reworked using an Orbital/DA sander that is not as abrasive or aggressive as a powered grinder. It was also evenly reworked across the surface to prevent any visual defect after painting.
